Re: Surface Soil Sampling Results — Former Wharf Road Area
Willamette Cove Upland Facility
Portland, Oregon
ECSI No. 271
1056-03

This letter presents the results of the incremental unit surface soil sampling activities in the former Wharf Road Area completed in accordance with the Oregon Department of Environmental Quality (DEQ)-approved work plan, *Revision to Proposed Surface Soil Sampling — Former Wharf Road Area* (dated June 25, 2012). The sampling activities were conducted to support the preparation of the Source Control Evaluation (SCE) for the Willamette Cove Upland Facility (the Facility; Figures 1 and 2) in the St. Johns area of Portland, Oregon. Work at the Facility is being conducted under Voluntary Agreement EC-NWR-00-26 between the Port of Portland (Port), Metro, and the DEQ.

Former Wharf Road Surface Soil Sampling
Port of Portland / Metro
Willamette Cove Upland Facility - Portland, Oregon

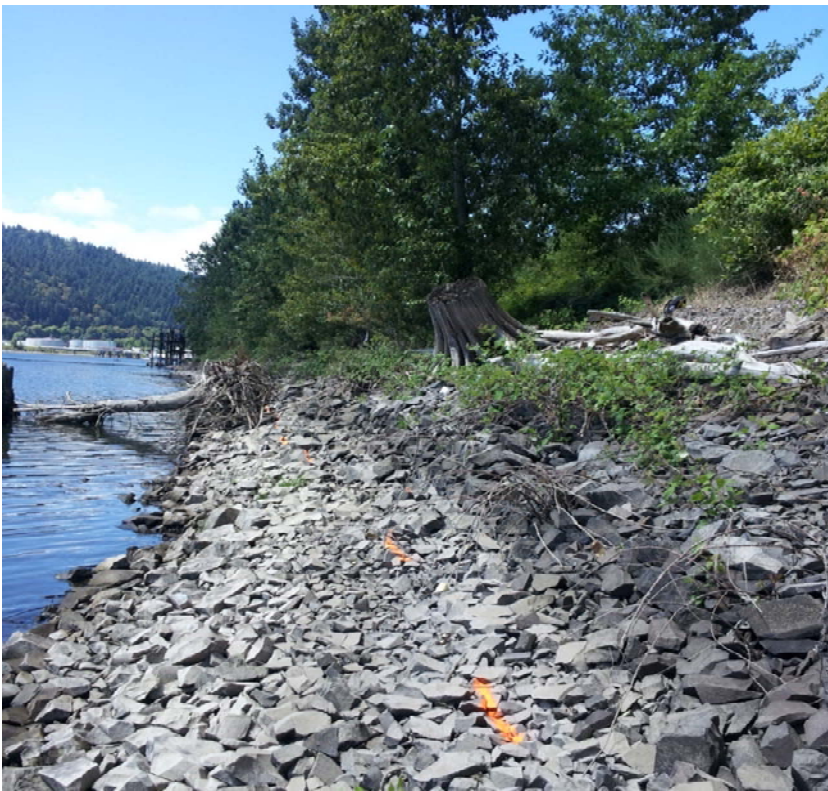
Photo No: 1

Photo Date: 8/2/2012	
Orientation: West	
Description: Mean High Water Line marked with orange paint on armor rock.

Surface soil samples were collected from three decision unit areas (DU-1 through DU-3) using an incremental sampling technique to assess the extent of dioxin/furans (Figure 3). Two of the decision unit samples, DU-2 and DU-3 were collected laterally and DU-1 was collected toward the top of the riverbank slope. The lower margin of the decision units was located at the approximate Mean High Water Line (MHWL). The MHWL was surveyed by Statewide Surveying (under subcontract to Ash Creek) on August 2, 2012 (Photograph 1; Attachment A). Each decision unit was comprised of an area of 50 feet by 100 feet.

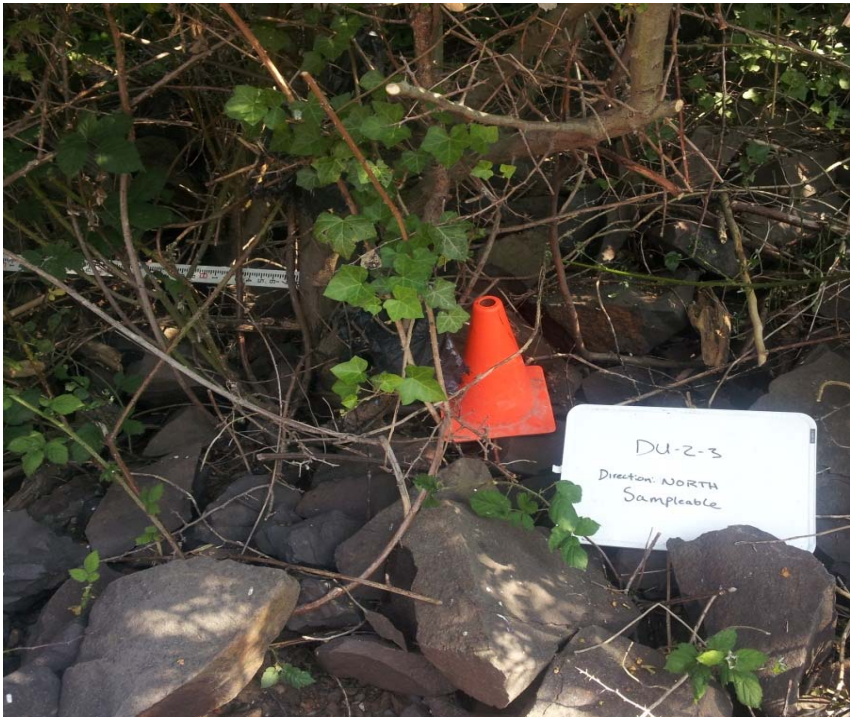
Photo No: 2

Photo Date: 8/6/2012	
Orientation: South	
Description: Typical sampleable location within armor rock. Note the limited material available for sampling.

Each decision unit sample consisted of thirty soil increments collected each 10- by 17-foot rectangular grid area within the decision unit (Figure 3; Photograph 2). The increment sample locations were established using a high-accuracy, handheld global positioning system (GPS) device (Trimble® GeoXH™). Where tree cover reduced satellite coverage and limited the accuracy of the GPS device, the grid centers were hand measured using a surveying stadia rod. The lower portions of the lateral decision units overlapped the armoring present on the riverbank. In cases where the grid was not sampleable (e.g., due to the presence of armor rock, presence of a concrete pad, or very thick poison oak coverage; Photographs 3 and 4) the sample location was moved to the nearest upslope grid that was sampleable. The sampleable increments collected in the lower row were typically only minor patches of materials within the armor rock (Photograph 2). The only exceptions were grids DU-2-4 and DU-2-5 which were relocated to the west of DU-2-1. The sample locations are presented on Figure 3.

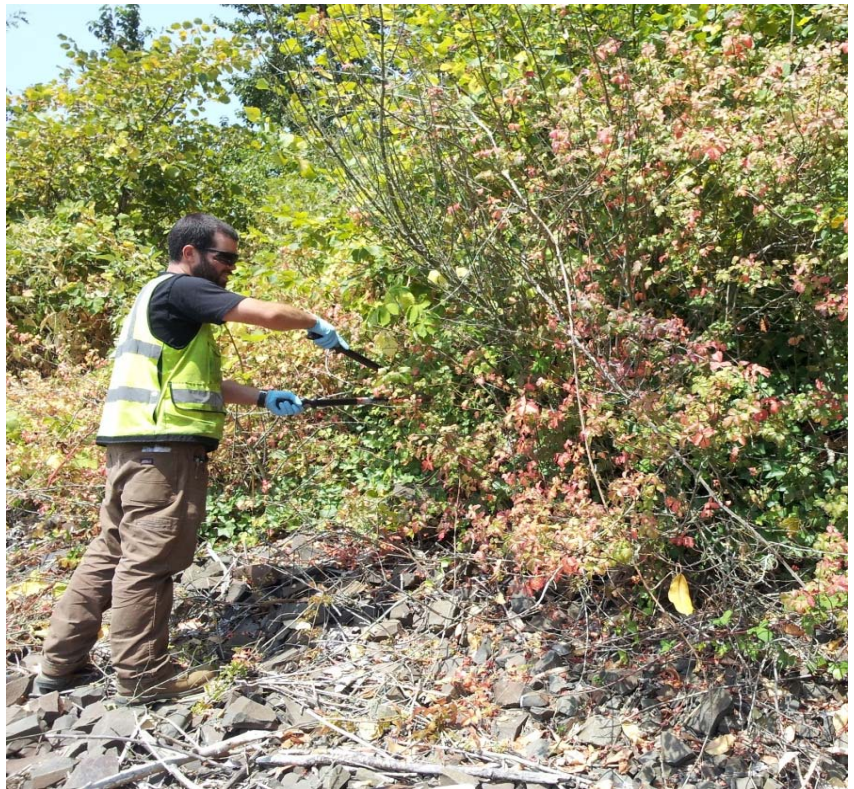
Photo No: 3

Photo Date: 8/10/2012	
Orientation: Northwest	
Description: Attempt to gain access through poison oak bush.

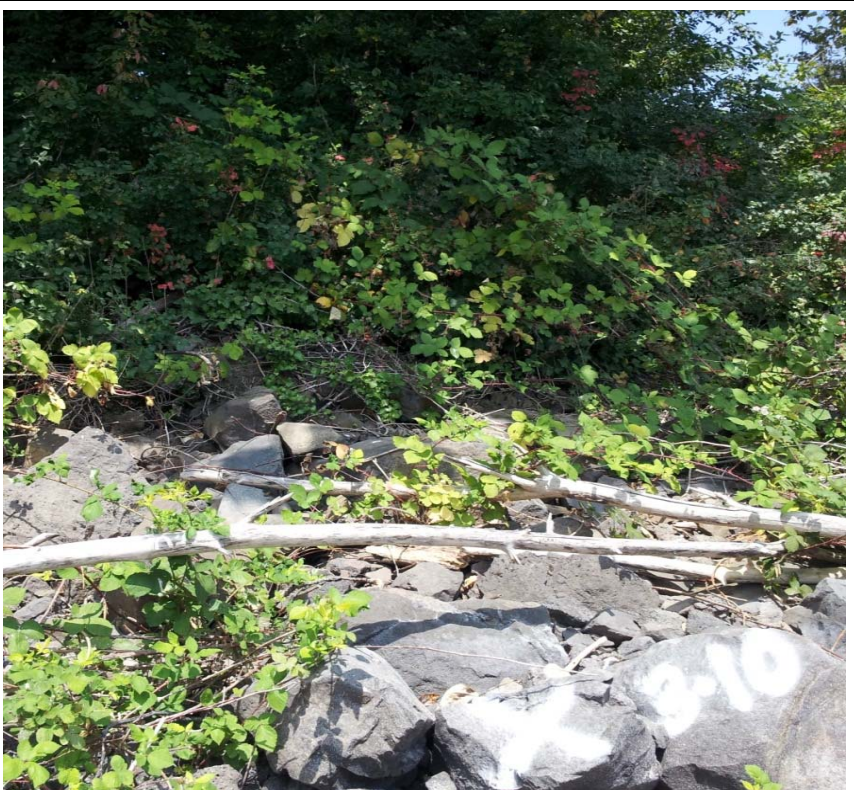
Photo No: 4

Photo Date: 8/10/2012	
Orientation: Northeast	
Description: Example of sampling grid covered with poison oak.

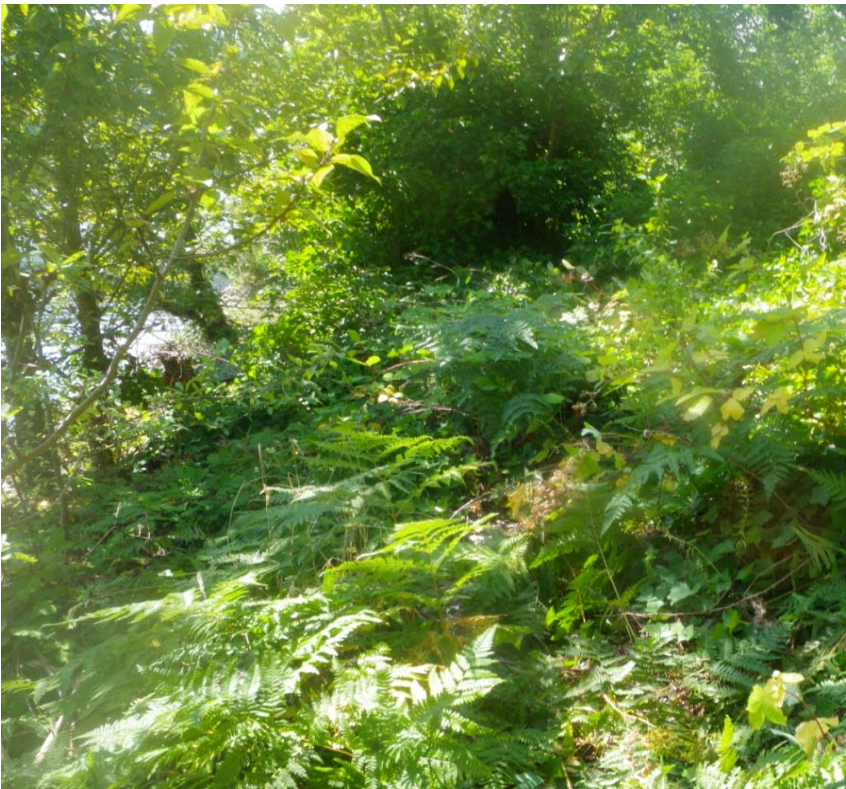
Photo No: 5

Photo Date: 8/7/2012	
Orientation: West	
Description: Typical vegetation present middle to upper riverbank.	
Photo No: 6

The soil increments were collected from the top 6 inches of surface soil after removing vegetation (Photograph 5). The target mass of each increment was approximately 50 grams in order to achieve the overall target sample mass of 1.5 kilograms for each decision unit. A six-inch hole was initially excavated with hand tools (e.g., shovel, rock bar, etc; Photograph 6). A 50-gram increment sample was then collected from the sidewall of the hole using a sampling spoon and added to the sampling container for the decision unit. A No. 8 sieve (2.4 millimeter slot size) was used in the field to aid in the removal of gravels and organic debris. The increments were weighed in the field using a digital scale. Traditional duplicate samples were not collected, but a field replicate sample, DU-1R, was collected from DU-1. Each increment for the replicate sample was collected approximately 4 feet west of the primary increment locations.

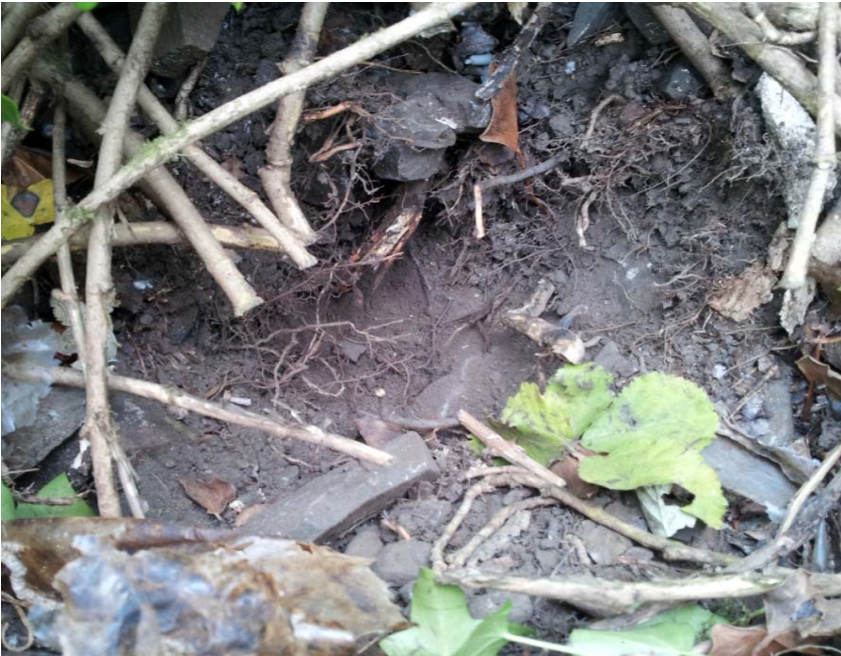
Photo Date: 8/7/2012	
Orientation: Not applicable	
Description: Typical penetration through vegetation. Note armor rock in hole.
